Lessons Learned on Future Application of Tepmachcha sensor units

TEPMACHA in Sangker District, Battambang province.

SENSOR MAINTAINING in Kamrieng District, Battambang province.

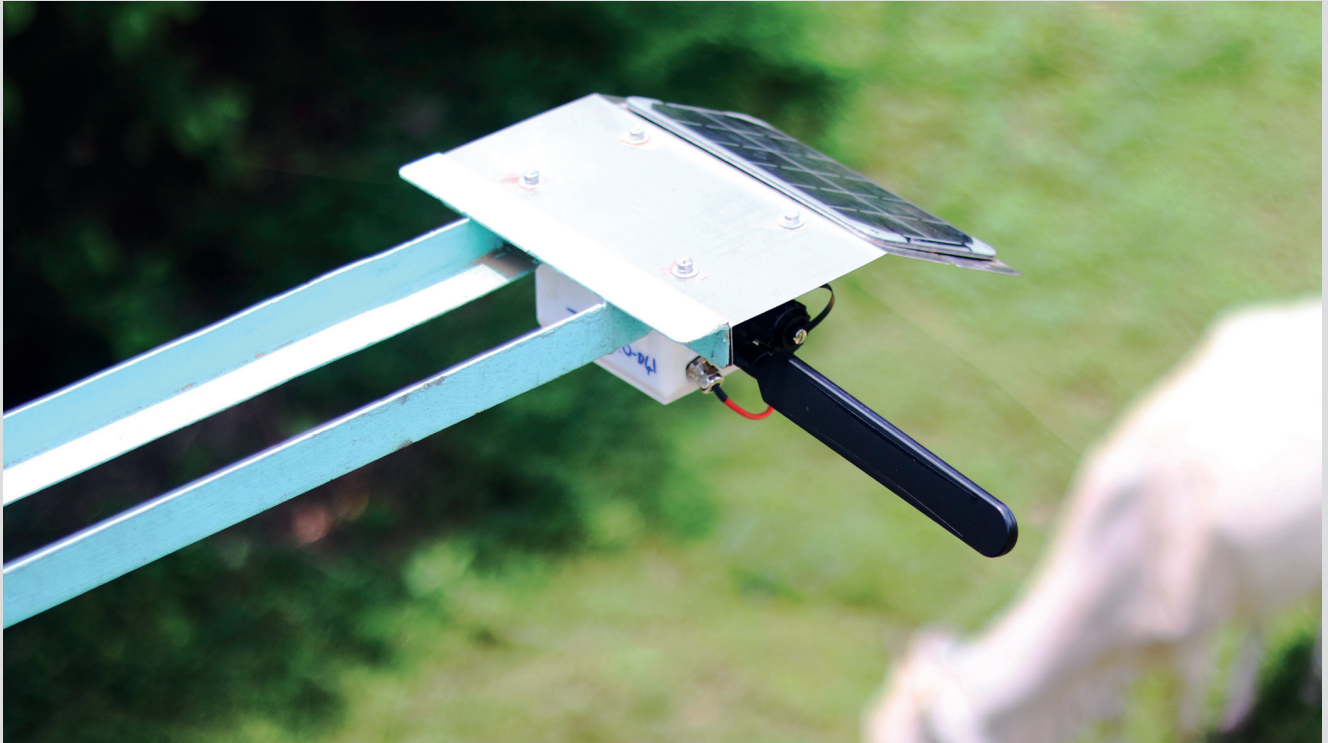
- Despite the resilient nature of the Tepmachcha sensor units, the harsh conditions that they experience in the field can cause faults. Previously, PIN would have to travel back to the sensor site to fix any problem that may arise, which could involve days of fieldwork and in some cases the issue required a simple solution (e.g. moving it to a location with better sunlight, removing obstructions, etc.). **In January 2020, PIN's DM team refined the sensor installation SOP, incorporating a detailed checklist to reduce the likelihood of easily preventable problems from occurring after they had left the site. Additionally, PIN now request the attendance of the PCDM, to ensure that they are fully aware of the sensor location, as well as requesting that they designate a local focal point. This has been extremely effective in reducing the number of maintenance trips, as the focal point can send photos to help PIN identify the issue. Furthermore, PIN created a simple sensor maintenance form, with a series of questions to support the PCDM in order to troubleshoot the issue.**

- Damage and theft have also proven to be a prominent issue, as local people often believe that they can sell the sensors parts to make money. Despite the use of complex locks to increase the security of the sensors, attempts are still made to steal the parts using heavy duty equipment. **The best way to prevent the problem is to encourage participation from the local authorities (Commune & Village Chiefs) when installing the sensors, as well as educating the community to increase awareness and understanding of the value that the sensor provides to local people.**

- The river warning levels are currently determined through discussions with local disaster management authorities. In urban areas these are often well defined and accurate. However, in rural locations they are mostly based on local knowledge and experience of historical events, which can sometimes lead to unreliable warning thresholds. **In these cases it would be better to use scientific methods to determine these river levels, such as consulting or creating a Digital Elevation Model, possibly through the use of drone RTK GNSS technology.**

- In March 2020, PIN Cambodia experienced a problem that was causing newly built sensors to fail to send recorded data, despite having seemingly identical parts to previously functional units. After a long troubleshooting process, it was established that the problem was caused by a firmware change inside the new generation one of the sensor parts. This required PIN Cambodia to sign a contract with a local electronics company (ArrowDot) who were able to reprogramme the sensors and overcome the problem. This solution led to PINs desire for ArrowDot to be more heavily involved in the sensors for EWS1294, initially through technical support and now as the producer of the units. **The involvement of a local service provider will ensure greater sustainability of the system, especially after PIN has completed the full handover to the government.**

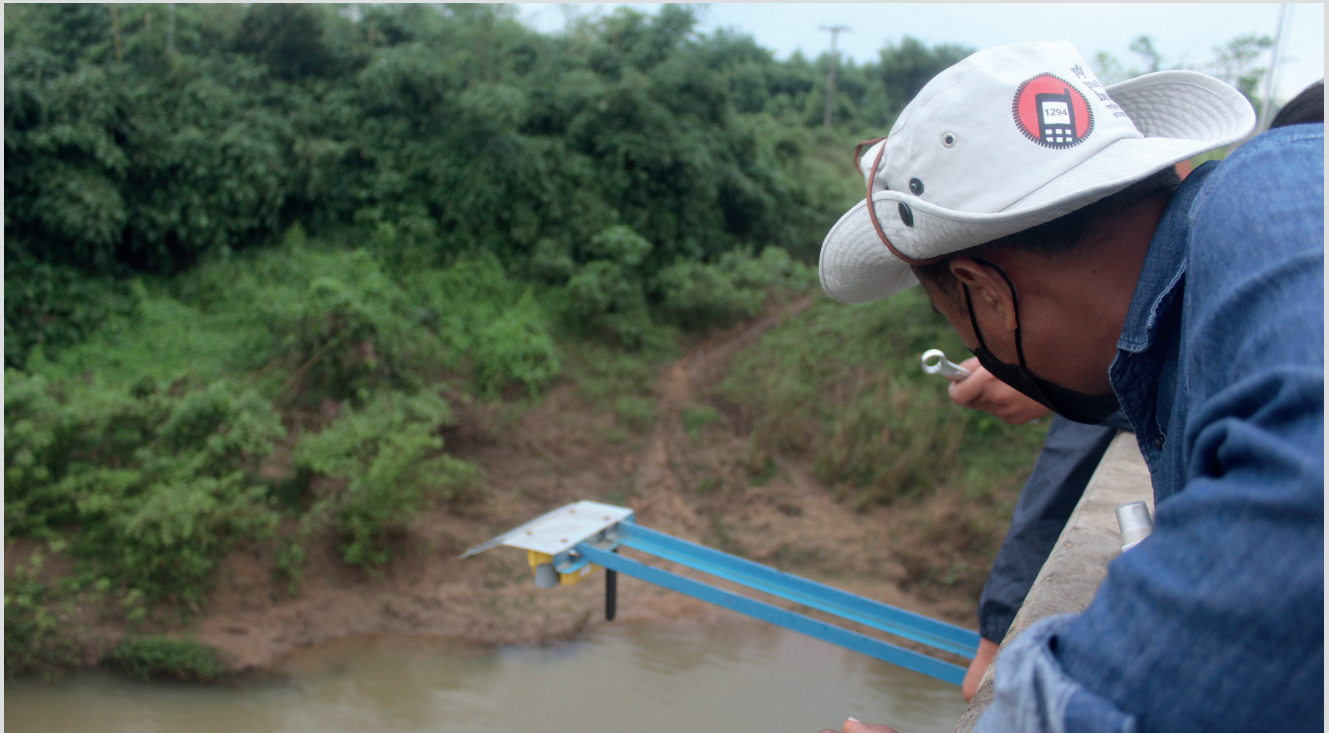
- Previously the sensors were programmed to send data at 15-minutes intervals and to go into a 'sleep state' in between data sharing phases. This was initially to ensure that the batteries sustained enough power to continually operate. Unfortunately, during the reprogramming to solve the problem in March 2020, the software engineers were unable to reprogram them at these set intervals and instead the data is now being sent roughly every 3 minutes. In the long-term this is unsustainable, as the system is now recording and storing 5 times as much data as it was before, overloading the online storage system and slowing down the data visualisation on the dashboard. This has led to our Senior IT Consultant having to eliminate vast amounts of data on multiple occasions, as a quick fix. Additionally, during periods of limited sunlight the battery life of the sensors is now reduced, as they are 'active' for a longer period of time. PIN plans to fix this problem, following the migration of the EWS1294 server to the local service provider (ArrowDot), as they will have more control over the internal programming after this change. **Hence, if a similar sensor model is to be adopted, it would be recommended to minimise (within reason) how regularly data is recorded and shared, whilst considering the implications on battery life during times of reduced sunlight.**

- Occasionally the sensors record unusual fluctuating measurements, despite regular river conditions and the unit appearing to still be fixed in the originally installed position. After closer inspection, this discrepancy between the measured and observed data can often be attributed to the formation of a spider web inside the sonar sensor part of the unit. In the short term, this can be fixed by carefully removing the spider web, however PIN Cambodia are currently in discussion with the local sensor service provider to establish a long-term solution, possibly by coating the sonar part with a protective lubricant. **Disruptions like this have demonstrated the need for focal points who are located close to each sensor. This enables minor issues to be solved quickly, without having to send a team to maintain them or replace each unit.**

- The sensors require internet connectivity and generally Cambodia has good internet coverage, however this is not the case in some rural locations. **Hence, PIN's DM team always check the strength of the cell signal using a phone with the same sim-card provider at the provisional installation site.**

- In December 2020, around half of the active sensors turned inactive within a few days. After a long troubleshooting process, PIN established that this was due to an internet usage limit placed on the sim-card inside the sensors. **This problem was mitigated by contacting the telecommunications company and removing the usage limit across all sim-cards. Note that this issue was caused due to the increase in the rate of data sharing during the previously mentioned reprogramming of the sensors, further demonstrating the need to carefully consider the data sharing interval.**

- The EWS1294 sonar sensors have a range of 10m. Hence, the warning levels need to fall well within that range, to ensure that there is enough time to identify the increasing river water level. This was not the case for a previously installed sensor in Ratanakiri, where the unit had been installed in the middle of a high bridge. **The sensor was eventually moved towards one side of the bridge where it could instead record the increasing water levels on the sloped riverbank.**

- Despite strong efforts to reduce the likelihood of faults, the EWS1294 sensor network still experiences numerous sensors turning inactive, which can sometimes take weeks to repair due to PIN's limited fieldwork availability and long travel times. **PIN Cambodia, therefore, aims to train NCDM and then the PCDMs on how to fully replace the failing sensor units with new devices. The ideal scenario would be for spare sensors to be on standby at each of the PCDM buildings (in each province) and for them to replace the faulty units as soon as they identify that they have gone offline without any support from PIN. This will require considerable capacity building and TOTs to NCDM.**
